Boleskine House, Foyers

Existing Fabric Record Report

by LDN Architects LLP

October 2019

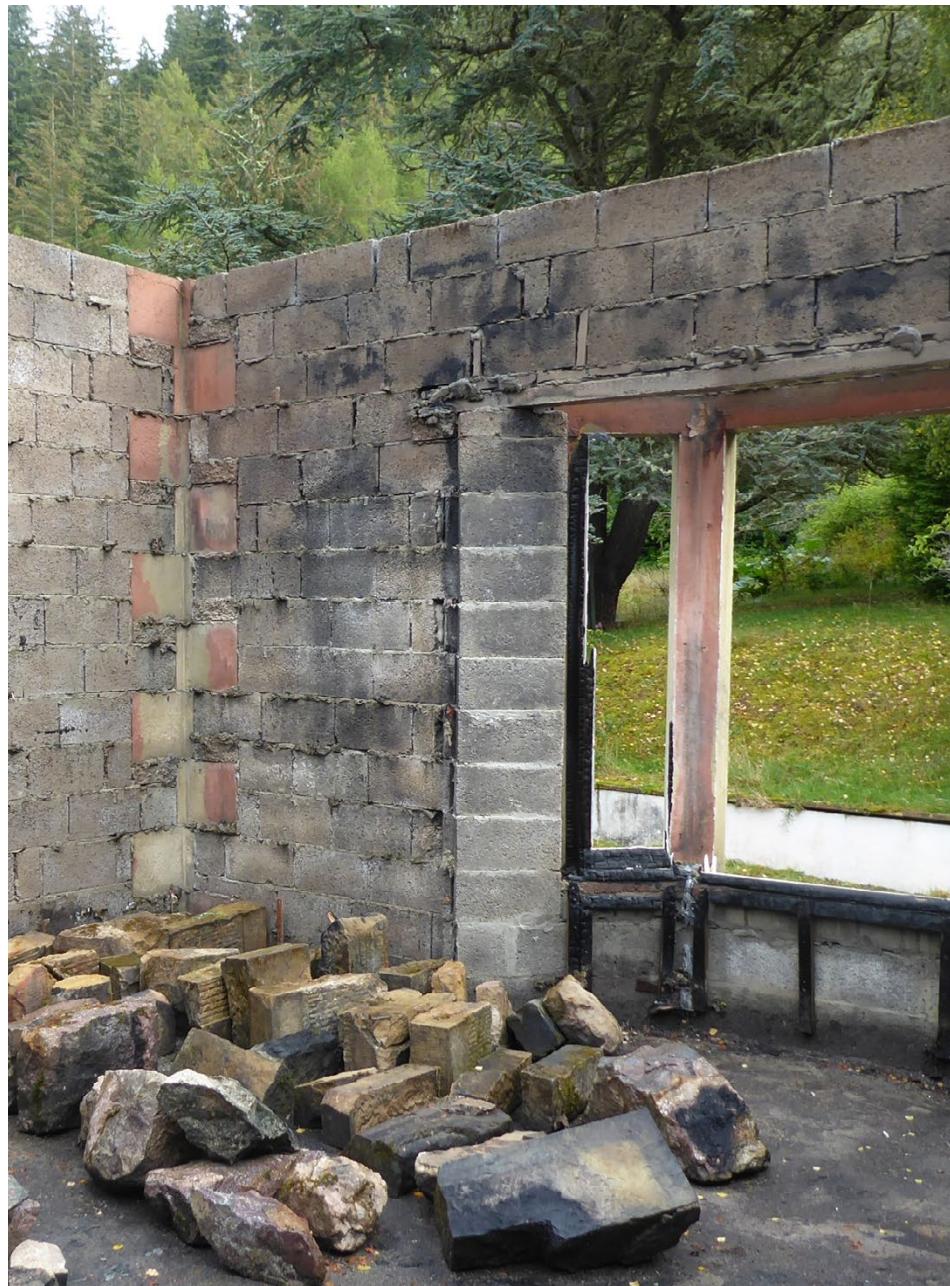
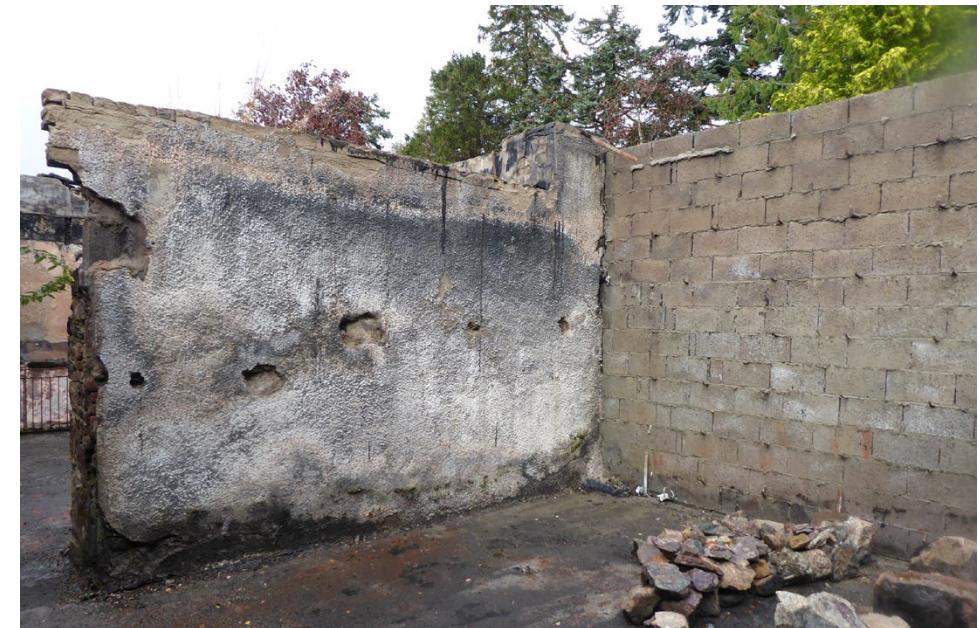
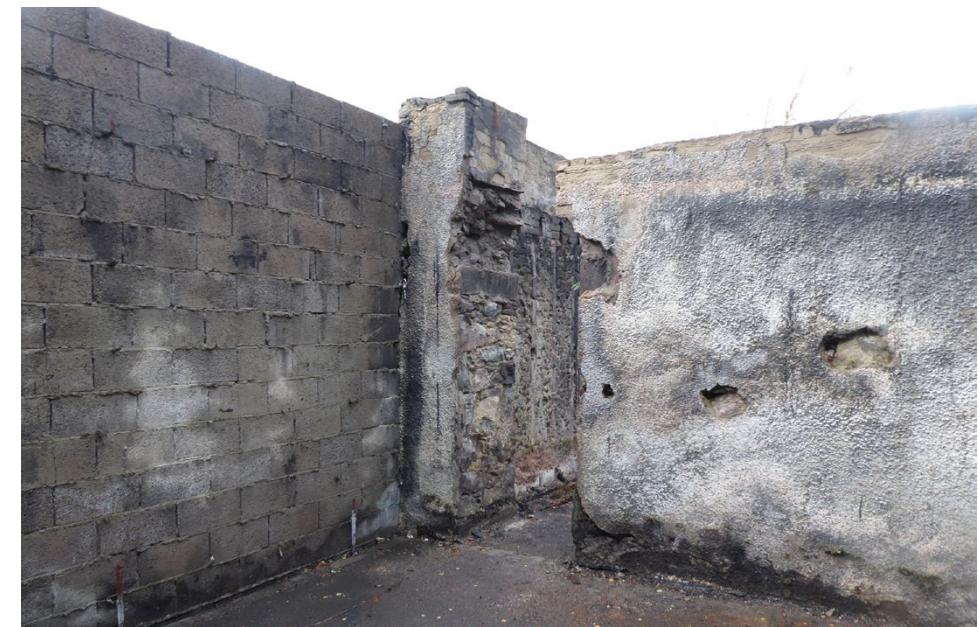
## ROOM ONE

Description: Eastern Return Wing, South-East corner.

Present on plans in 1926 but noted on drawing dating from 1970 'This part of wing to be reconstructed as originally' so removed in the intervening period.

Rebuilt in timber frame (drawings dated 1996) with a single leaf of blockwork as its external skin. Precast reconstituted stone dressings to bay window and quoins.

Timber frame now burnt out leaving blockwork skin (2380mm high) free standing. Wall shows signs of distress, evident in extensive cracking in cement render finish.

Existing concrete floor within. 1996 drawing shows this is set 60mm below original floor level and had a floating timber floor.

Evidence of surviving cement roughcast on North-East wall shows that this current construction is a later extension and for a period this wing was truncated. Sandy Gracie drawing from 1996 notes that doorway into extension created at this time.

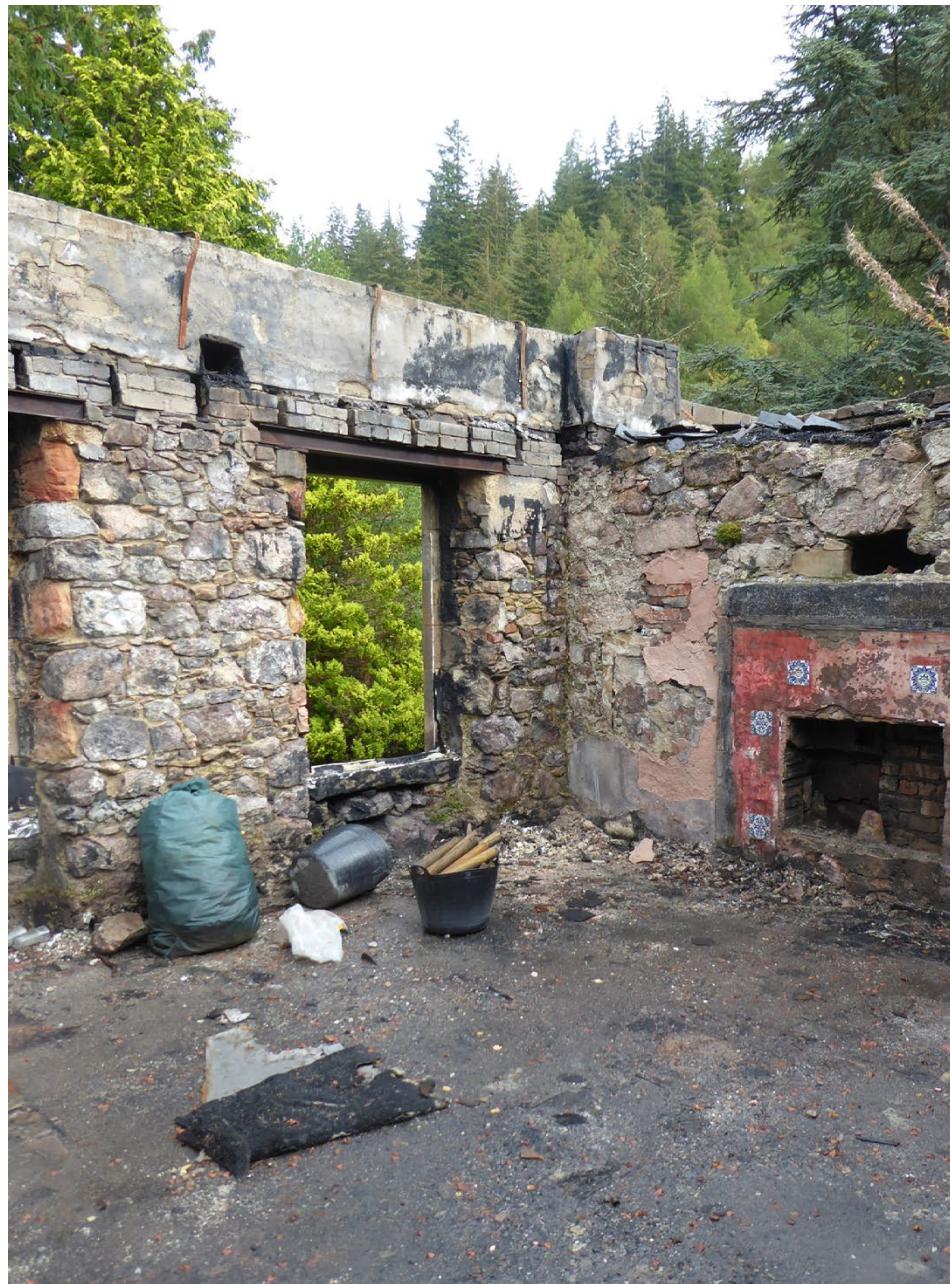
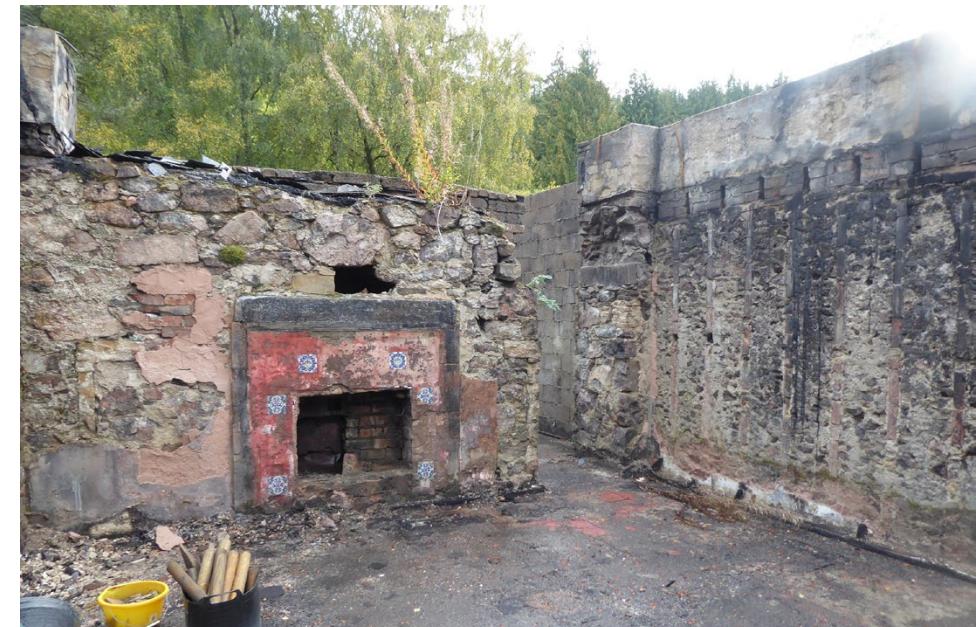
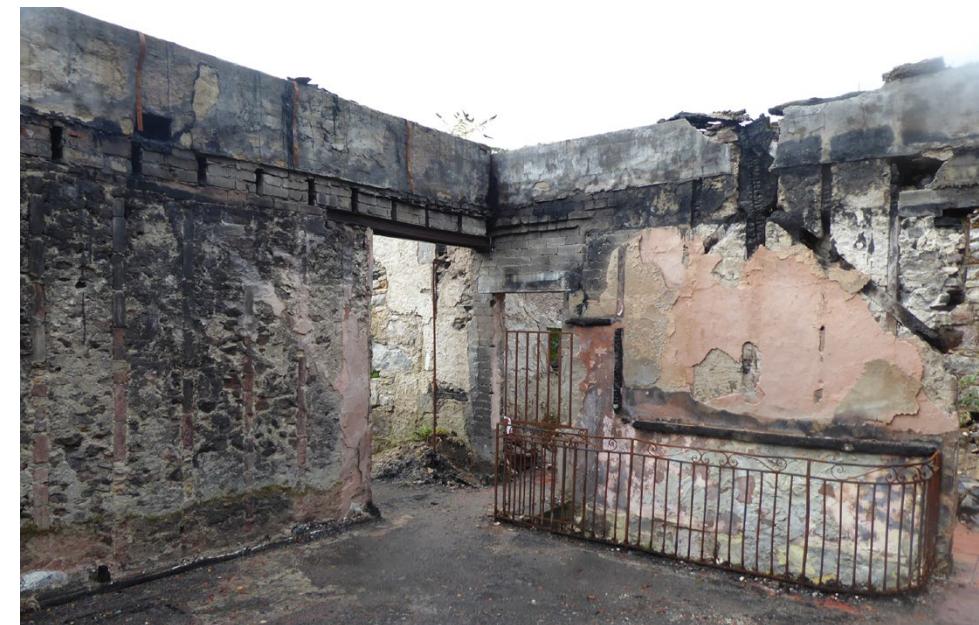
## ROOM TWO

Description: Eastern Return Wing, centre.

Rubble masonry construction up to window head level, above which wall has been rebuilt in concrete brickwork roughly 1.0m high.

Ceiling joists at 2750mm F-C which is roughly 1.0m short of the current wallhead.

Drawings from 1996 do not show this as rebuilt but do show modern gang nail trusses and a new Spanish slate roof over this wing. This suggests that the rebuilding of the wall heads took place when the house was extensively remodelled in 1970.

Solid concrete floor flush with Room One and therefore 60mm below First Floor Level.

Rubble built South-East wall to Room One is 960mm thick and contains evidence of a larger infilled fireplace and a more recent smaller range. This wall is patched in brick and retains some modern gypsum plaster. The 1996 plan drawing shows a bathroom in this vicinity. This wall varies slightly in build from the external wall to which it is attached suggesting that it may have been built at a different time. The chimney wall was inserted within the wing to divide and service the space.

The West wall to the courtyard is also a different construction to the other external wall to the East. It is constructed of smaller rubble and had vertical timbers embedded (since replaced in cut brick)

The East wall comprises larger fieldstone rubble brought to rough courses with sandstone dressings at the two windows. The safe lintels over these windows have been replaced with steel joists. As is the case, except where specifically noted, this rubble is metamorphic in nature and appears to comprise of local schists.

The South wall dividing Room Two from Room Three survives as a masonry pier (350mm thick), connected at high level to the East and West walls with blockwork infill above concrete lintels.

This central pier retains vertical and diagonal built-in timbers and includes a fire damaged king post. It therefore bears similarities to the West (courtyard) wall and is assumed to be of a similar date. As noted below, this wall retains evidence of harl on its rear side suggesting that it was once an outside wall. It is however unclear whether the timbers which are deeply embedded in the wall were built at the same time as the masonry surround or whether an earlier timber structure has been infilled and retained within a later masonry structure.

A stone staircase descends into a vaulted basement, the final winders hidden by debris. This basement is narrower than the room above. 3340mm, as opposed to 6300mm and shorter – 3600mm, as opposed to 5600mm. The vault is a shallow arch varying from 1350mm – 1800mm. One might have expected that if built at the same time this basement and the structure above would have shared their plan footprint. This suggests that the vault might predate the later structure.

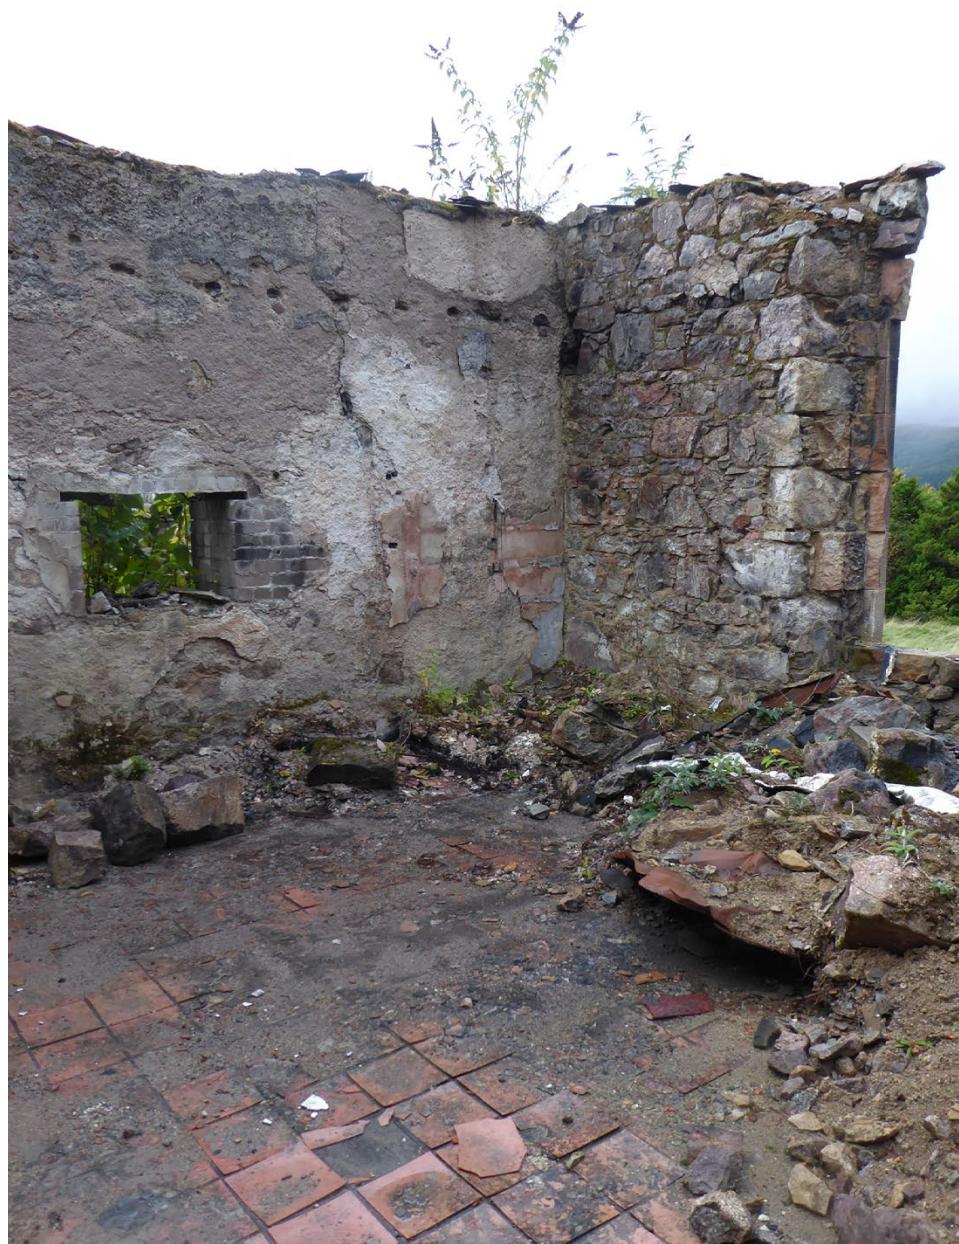
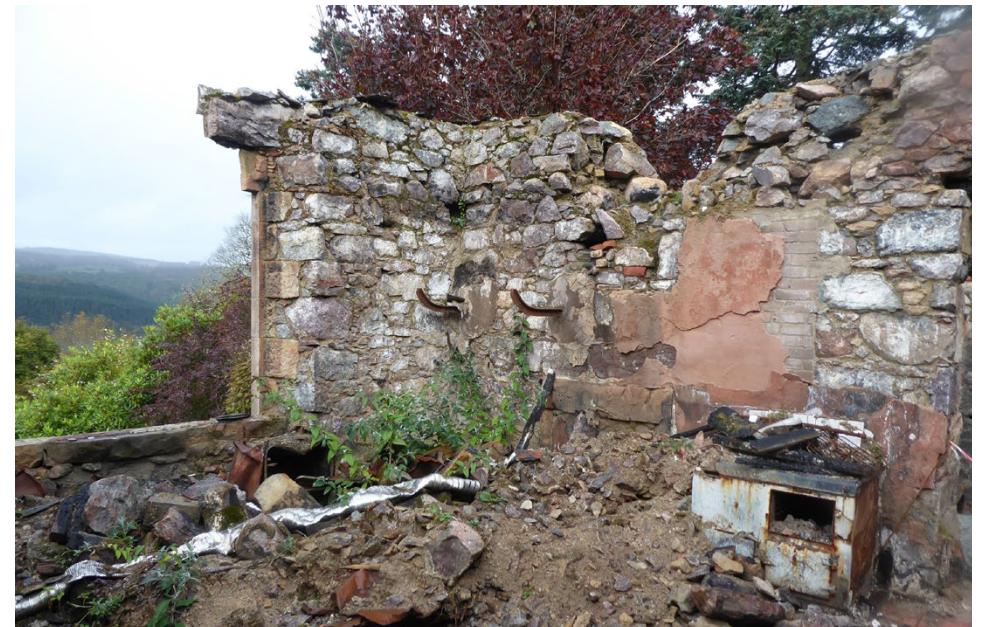
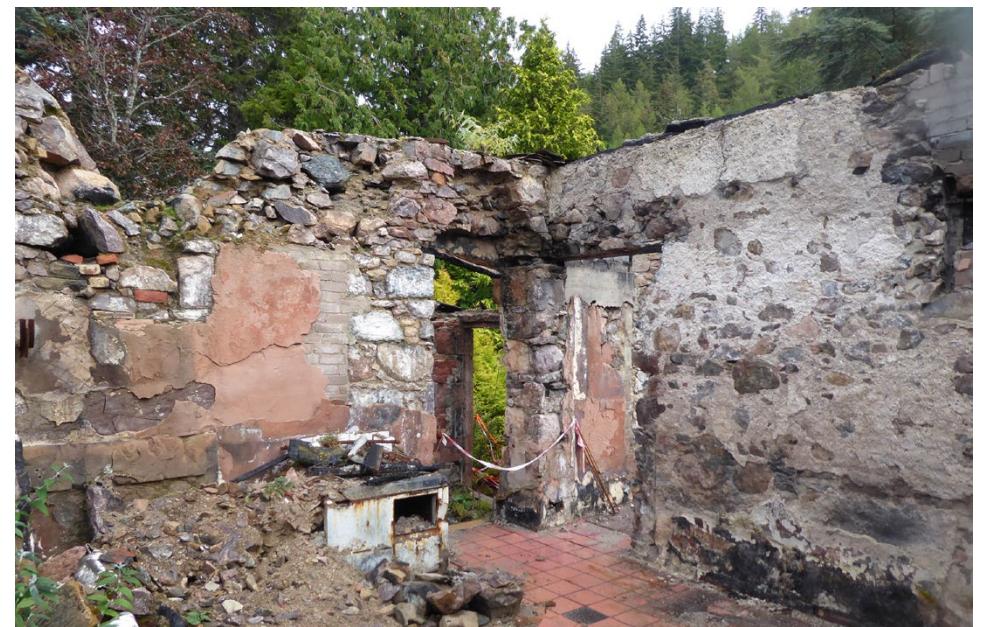
## ROOM THREE

Description: North-East corner.

Expressed as a recessed wing to the central block on the North-West Elevation and characterised by channelled quoins and dressings in yellow sandstone.

Built in coursed local rubble (600mm thick) with yellow sandstone dressings and highly expressed quoins which have chamfered corners on 3 sides to create a shadow in the channels, the fourth side designed to take a harl finish. Wallhead at approximately 4250mm. No interventions at wallhead in blockwork.

Surviving evidence of a Palladian window. Mullions now missing but clear evidence from photos that this matched that at the opposite end of the Lochside elevation. This suggests that these two wings either side of the central structure are of similar date and design and the window styles suggest that they date from the 1760-1830 period.

1926 plan shows this area subdivided into back kitchen areas. Wallhead chimney on East wall above extension (now lost) and fireplace lintel just visible behind rubble and Esse (?) stove. Concrete brickwork with Carlite browning plaster shows where flue broken into to insert lining.

Solid floor with ceramic tile finish as the space below is partly vaulted – see above.

Walls against both Rooms Two and Four retain external lime harl (and evidence of pockets at high level against Room 4) suggesting that this block has been inserted into the internal corner of an earlier plan form.

Modern serving hatch (?) cut through wall to former Dining Room (Room Four), formed in concrete brick and timber lintels.

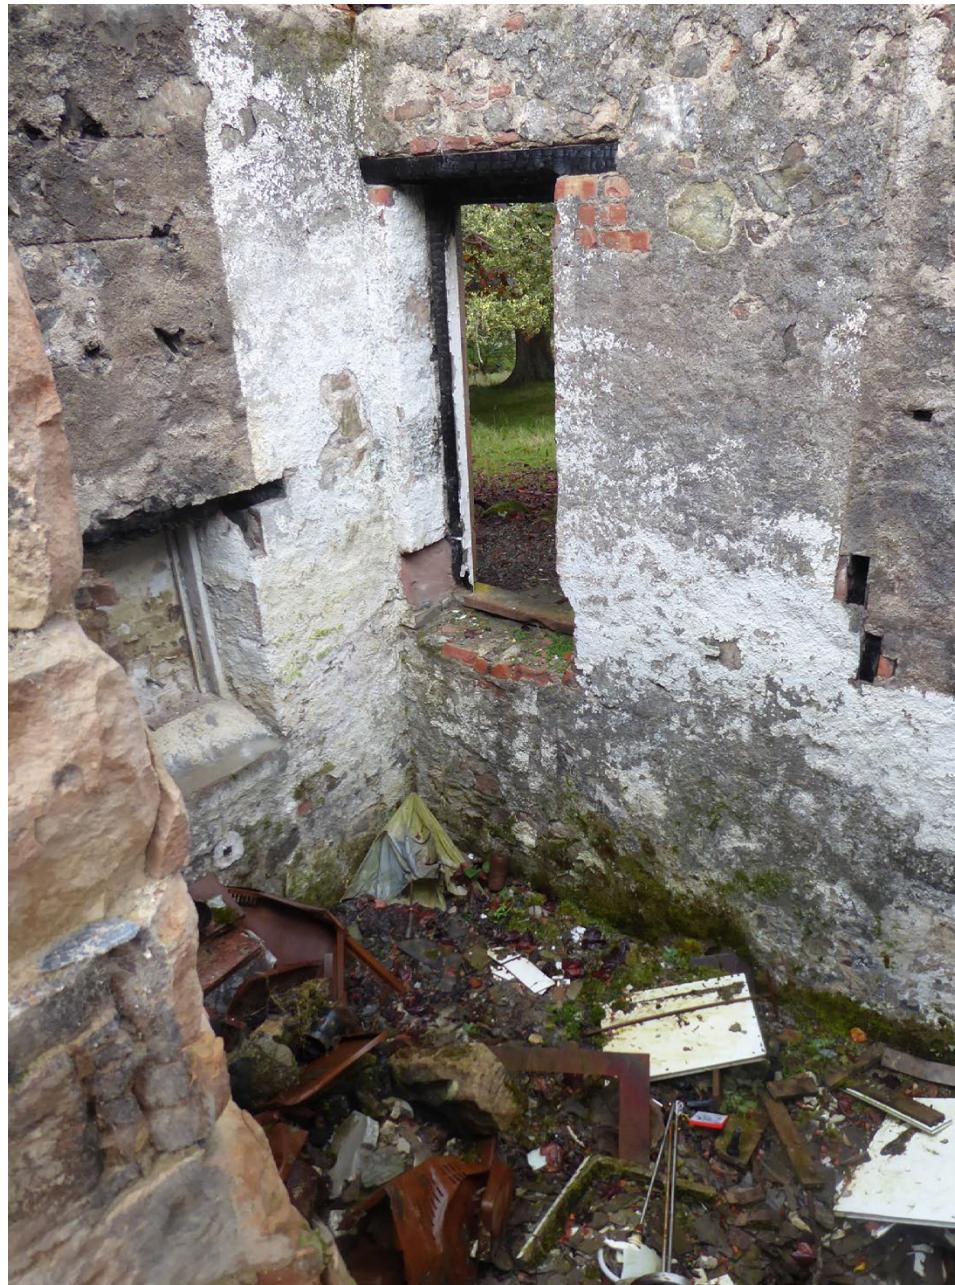
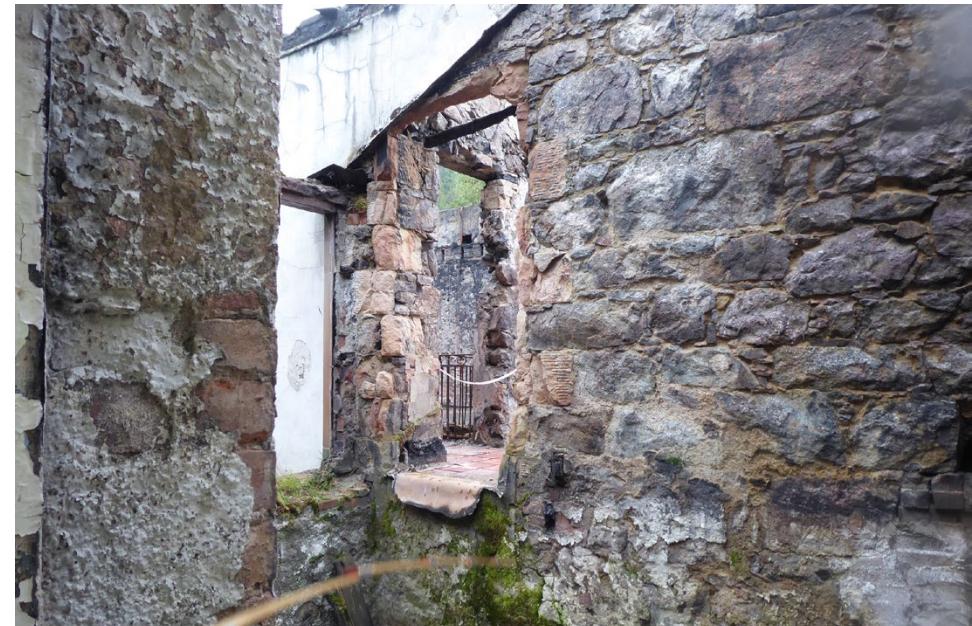
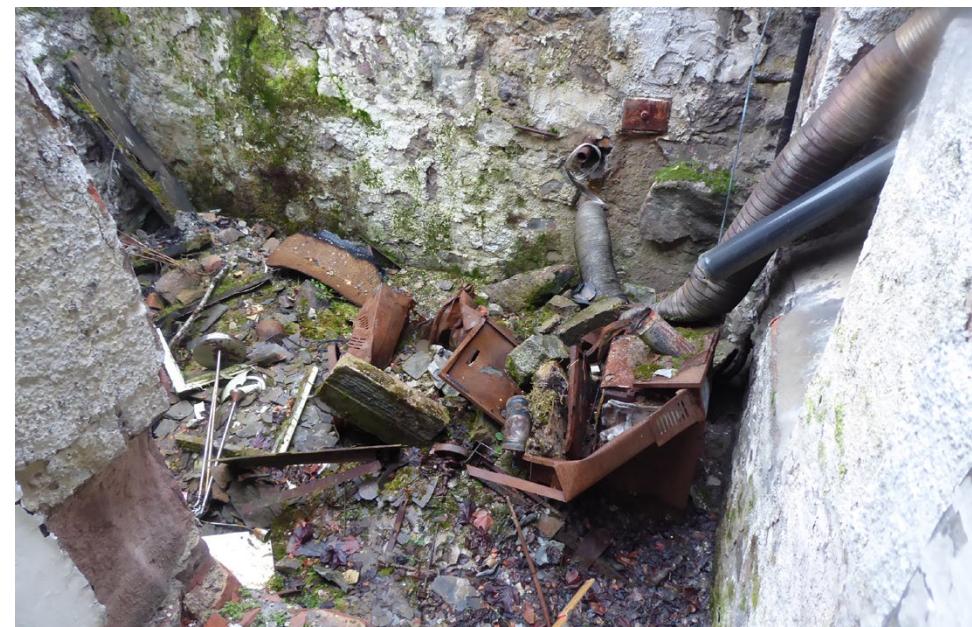
## EXTENSION

Description: Later addition to North-West over an earlier doorway.

Appears on plan dating from 1926 and shown on 1970 elevation with a piended roof. Seen in photo from 1912.

Masonry construction 530mm thick. Built in local red sandstone (probably Black Isle suggesting that it was brought in when road transport had improved) with evidence of surviving lime finishes on the hard within to confirm that it is a later addition.

Lower single storey construction with originally an external doorway leading to an internal timber stair to a low basement (c. 1800mm) containing the boiler.

Red sandstone margins to corners and openings with a modern cement harl set proud.

Construction appears sound, wallhead approximately 2900mm.

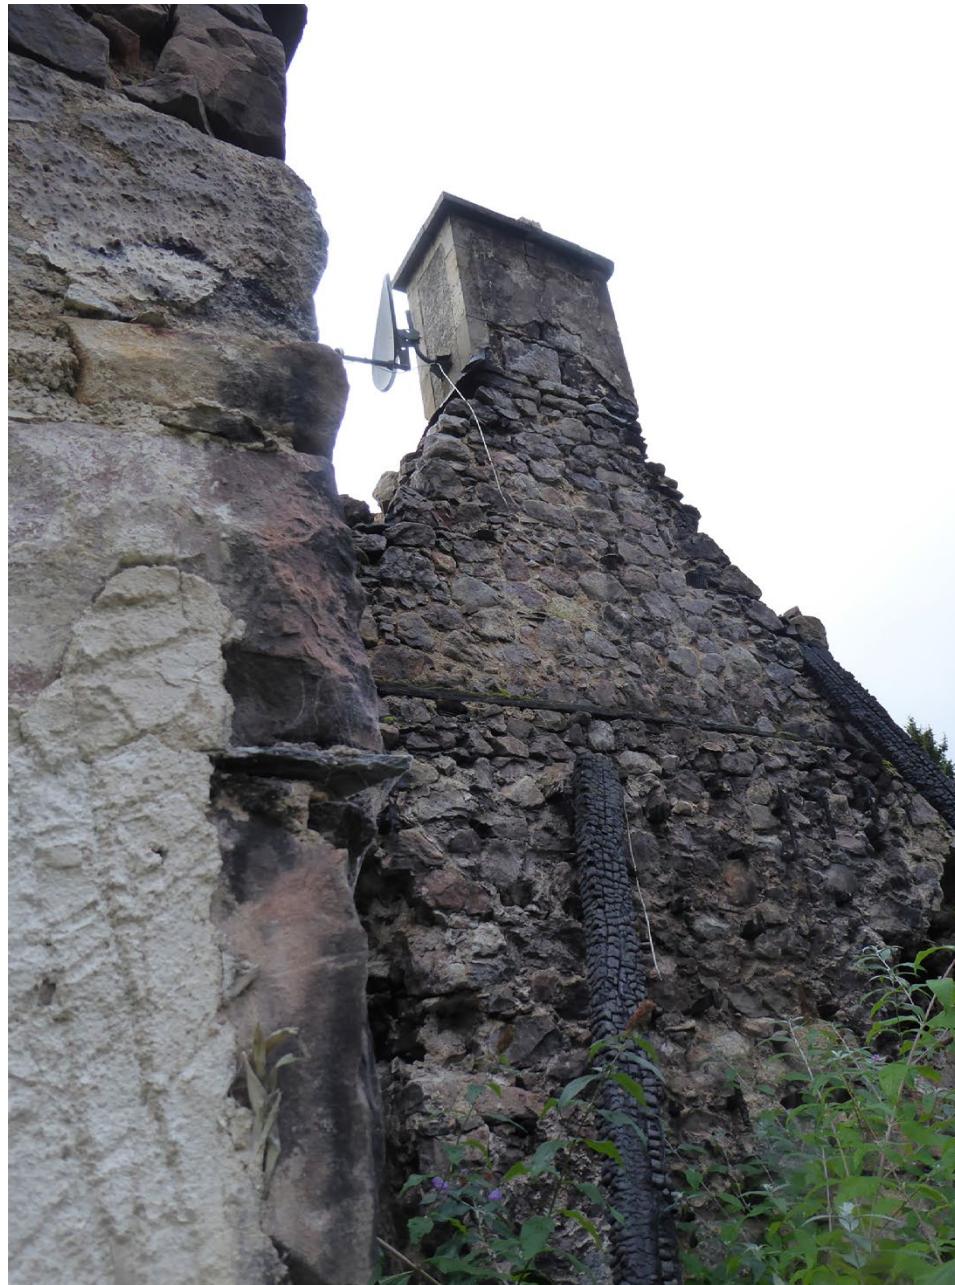
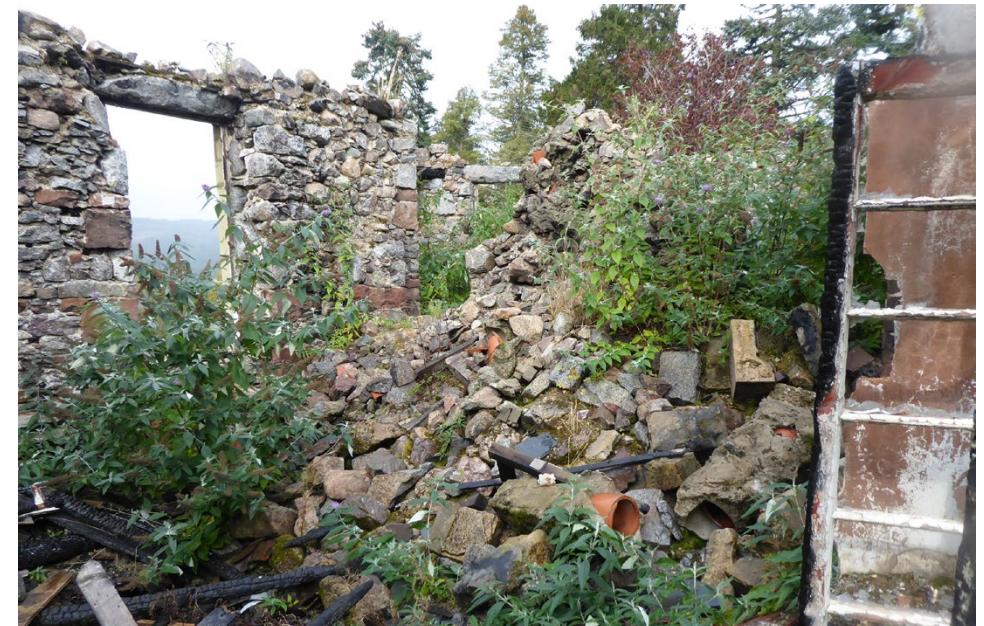
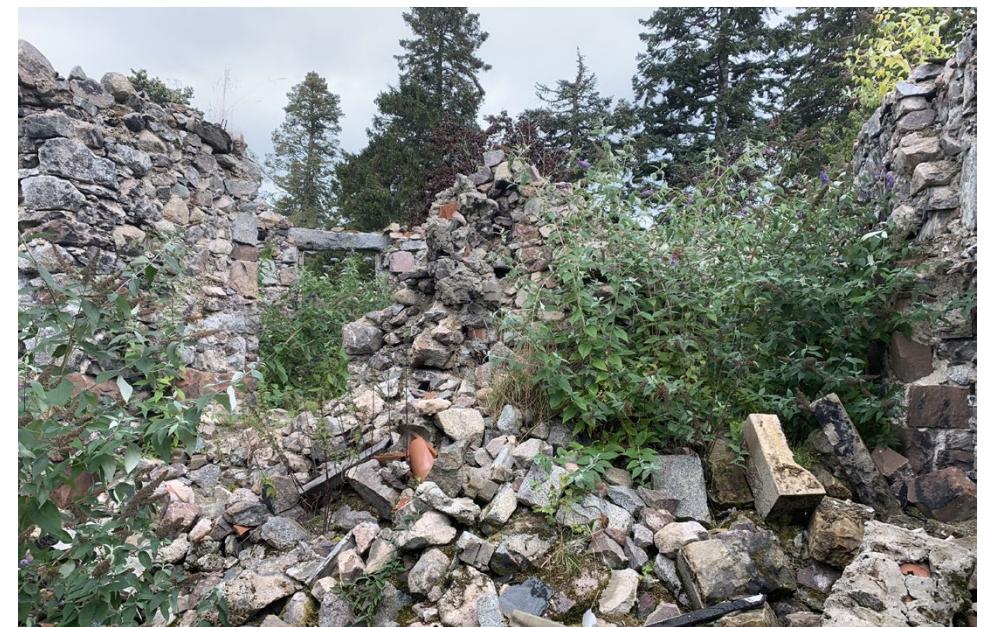
## ROOMS FOUR, FIVE & SIX

Description: Reads as a 3-bay central block facing the Lochside.

On the North-West (Lochside) elevation this element reads as a symmetrical elevation with two semi-circular bay windows and a central arched topped window over which was a piended roof (in photos).

These three rooms appear to be the original core of the building potentially predating 1760. They are built in random rubble, comprising local field rubble but with granite dressings to corners and openings (hidden below later expressed rendered margins within an overall cement harl). Thus, they differ from the surrounding wings and lack the channelled quoins seen on the wings.

These rooms had suspended timber floors pre-fire with a ventilated solum.

The wall to the South West (Entrance Hall/Corridor) preserves evidence of external harling on the hall side and at least one closed window suggesting that this passage is a later addition or has been remodelled and was once open to the air. As this South-West wall varies 500 – 380mm thick when the North-West side is 670mm thick and yet shows evidence of being an external wall, this suggests that while an external wall, it was protected. This supports a theory that it opened onto a covered loggia or roofed passage behind a colonnade. Plaster finishes in the South West end of the hall disguise the opposite end of this wall but the assumption is that it is symmetrical.

Two chimney walls divide Rooms Five from Four and Six. That between Rooms Four and Five has collapsed and lies within Room Five. This debris includes modern clay flue liners; evidence that the chimney has previously been disturbed.

The chimney between Rooms Five and Six remains in situ but appears unstable as it is no longer stabilised by the adjacent walls as these high-level masonry connections have been weakened where stonework has fallen when safe lintels have been lost in the fire over the doorway to Room Six and the wall press on the opposite side of the chimney stack.

This chimney has yellow sandstone margins with a harled finish and so may date from later than the lower structure, which is characterised by granite dressings. As it matches the chimney to Room Seven it suggests that it was altered when the wings were added probably shortly after 1760. The lack of surviving mortar in the masonry following the 2015 fire and a built-in horizontal now fire damaged timber at its base suggests this must be taken down temporarily.

One window in Room Six has been altered fairly radically by being both widened and shortened to create a door to a terrace, the alterations disguised by the render. Internal access will reveal whether the earlier window opening survives.

On the South-West side of this range, backing on to the corridor, the central opening on axis with the main entrance comprises a central doorway with two flanking openings formed in timber which appear to have been altered. All three openings have shallow fanlights. However, on either side of this, within Room Four, there is a suggestion of former doorways that may predate this axial approach.

There is no safe access to Room Six, but the chimney it shares with Room Five has two flues and the structural opening to Room Seven appears wider than the present doorway.

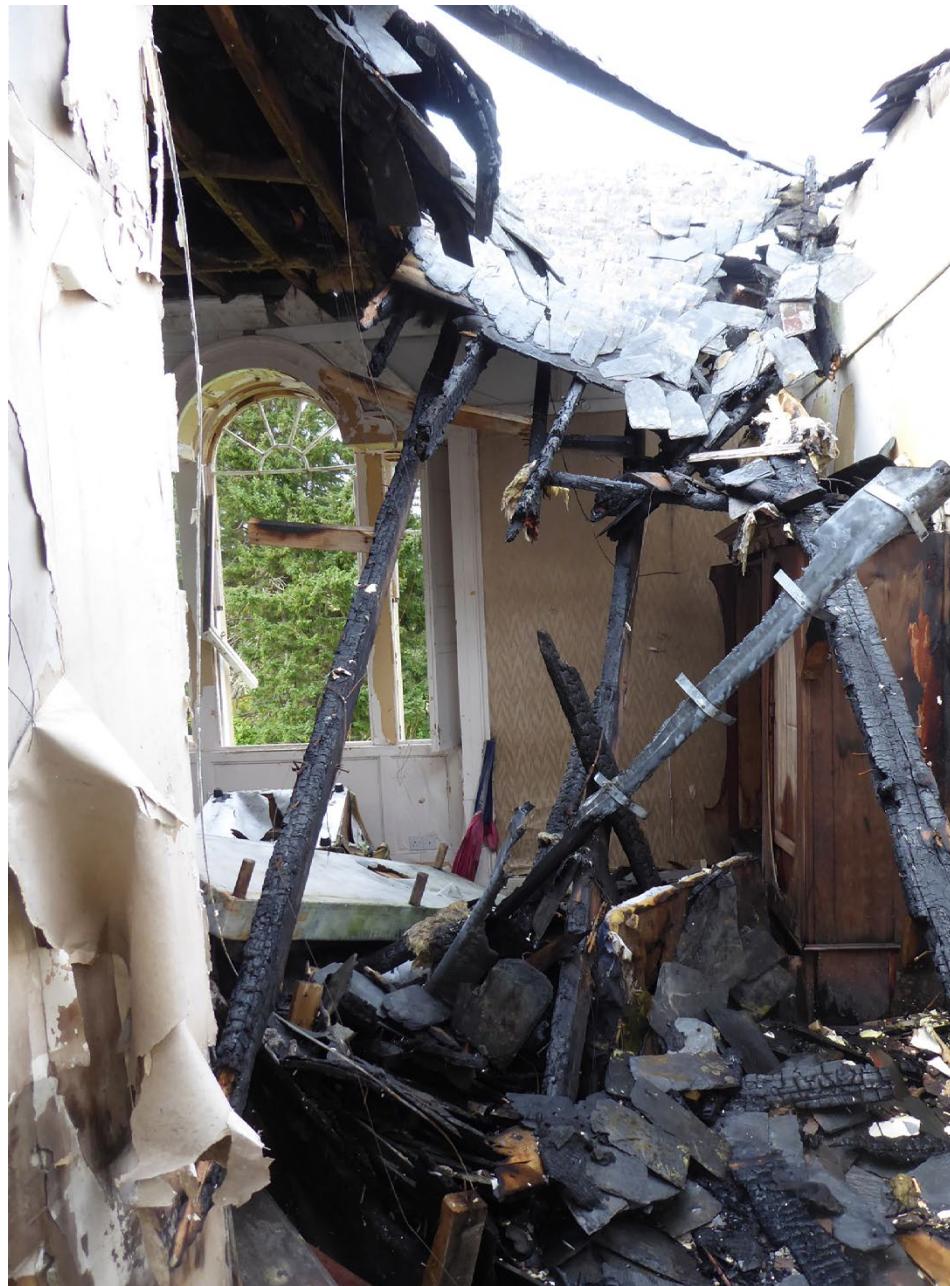
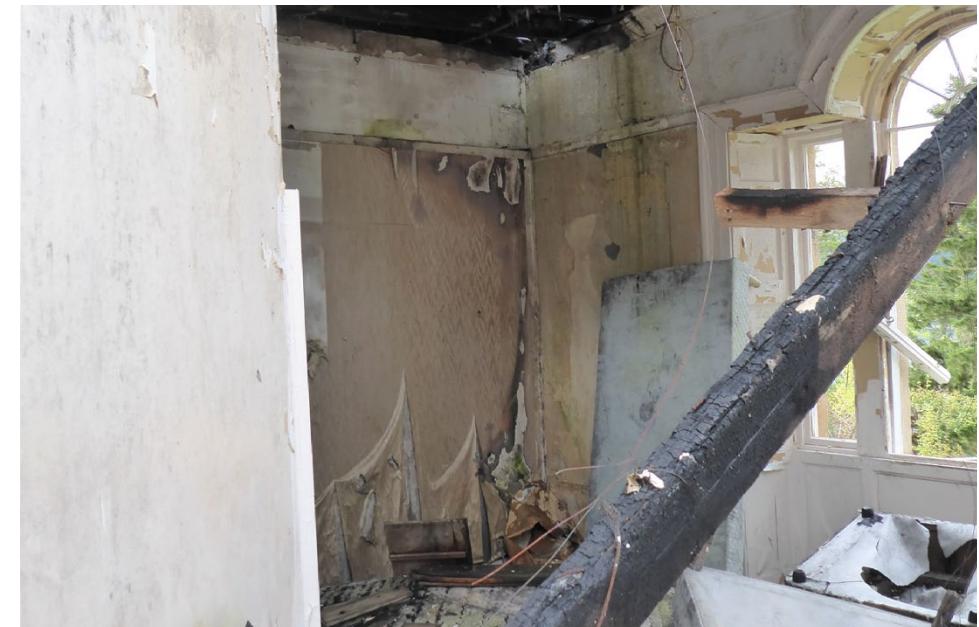
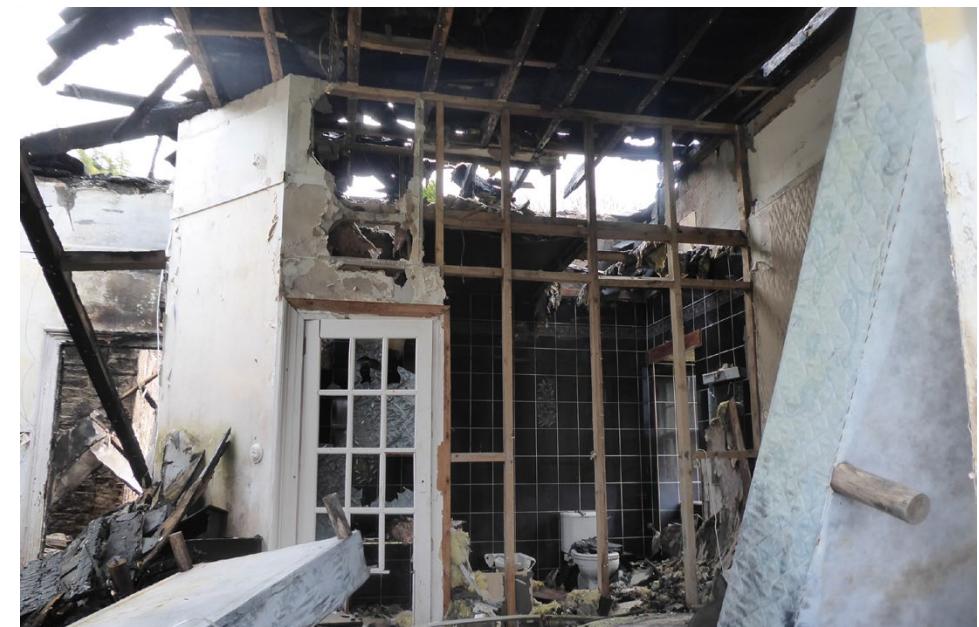
## ROOM SEVEN

Description: North-West wing.

The fabric forming Room Seven balances the recessed fabric of Room Three and includes a matching Palladian window of the same dimensions and matching channelled quoins. The width of this bay matches that of Room Three and hence this suggests it is of a similar age and design intent. A lack of access to Room Seven prevents finding evidence for external harl where it backs onto Rooms Six and Eight that would confirm that Room Seven is an extension built to infill a n internal corner between two earlier structures but this is the supposition.

As this room retains much of its modern finishes and part of its roof, it is not possible to see the masonry sub-structure which would confirm this.

This was most recently a bedroom and has been subdivided to include an en-suite bathroom.

This space has a suspended timber floor and probably a solum up to 600mm deep.

There is a wallhead chimney on the West wall that in total stands 7500mm high, approximately 3.0m above the wallhead.

This chimney has dressed sandstone margins, but lacks the harling seen on the adjacent chimney above Room Six. It is however of similar deign and potentially age.

The West window to the en-suite is of a different size and proportion to the others and quite likely a later addition as it includes a rendered margin which will probably be found to cover concrete dressings. In the 1926 drawing it is shown as a wall press. In the 1970 plans it exists as a window.

If, as suspected, the extension proposed in 1926 was built and then subsequently removed, this West chimney wall would have been extensively altered, becoming an internal wall, the extension entered via Room Eight.

However, the window in Room Eight shown as a doorway in the 1926 plans appears undisturbed externally and has a stone sill which one might have expected to have been lost and replaced in concrete.

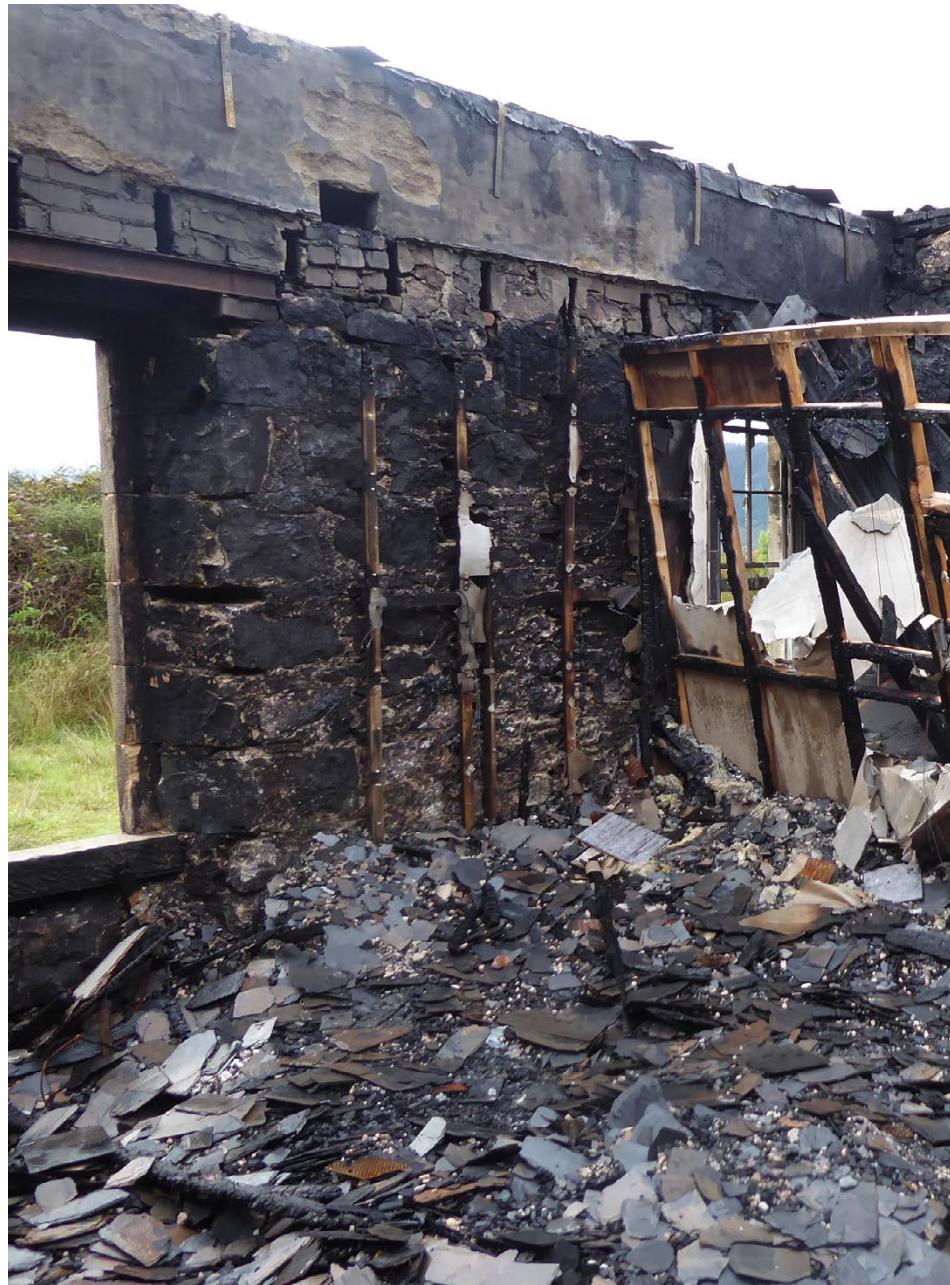
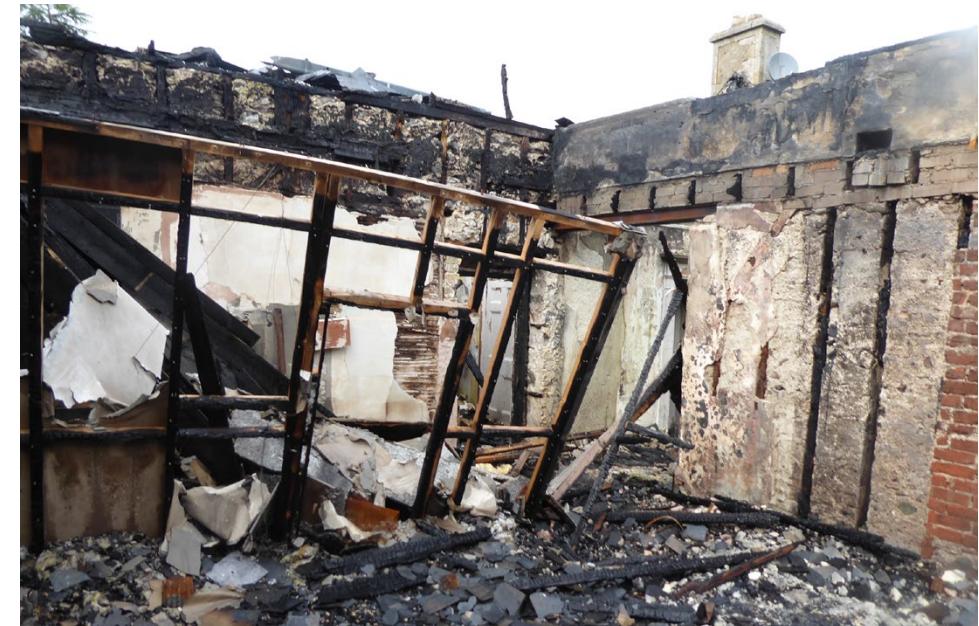
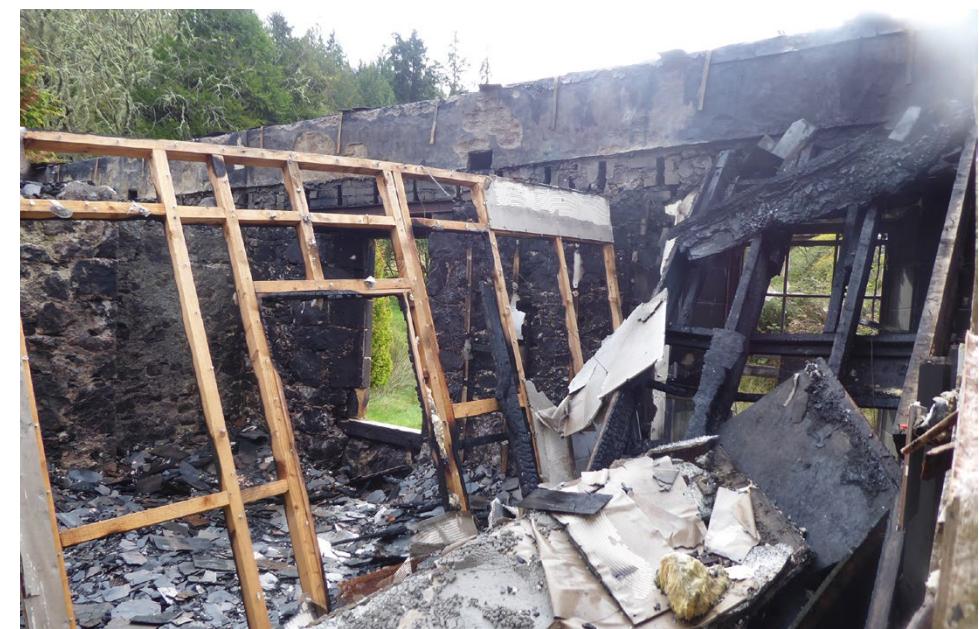
## ROOM EIGHT

Description: Western return wing, centre.

Room Eight was the site of the most recent fire and is filled with debris, but it has distinct similarities to the construction seen in Room Two in the other symmetrical wing.

Hence the North wall backing onto Room Seven and the 350mm thick East wall to the courtyard have built-in timbers in a rubble matrix, comprising small stones and the suggestion of a king post in the same relationship. Unlike in Room Two, these have not been infilled in brick and so have been burnt away

The large opening to the courtyard has been altered in red brick at a later stage to create an additional window. The size of the original opening suggests an outbuilding doorway.

The East and West walls have been heightened at probably the same time as the alterations took place at Room Two, with the upper 1.0m rebuilt from lintel level in concrete block and timber safe lintels replaced with steel lintels.

The West wall differs in construction (and at 580mm, is much thicker than the East wall to the courtyard) and the yellow sandstone dressings to openings suggest that it is of an age with Rooms Seven and Three. Surviving finishes disguise any alterations made in 1926 to the North West window.

The South chimney cross wall, at 800mm, is thicker and in construction terms appears to differ from both the external walls and may be of a different age and appears to have been inserted into an older construction which may have then been subsumed into a later alteration as there is surviving harl on the chimney cross wall within Room Nine.

This chimney wall stops short of the wallhead and has dressed stones at the opening into Room Nine, with a recess on the opposite side of the fireplace. A lack of debris suggest that this chimney had been taken down before the fire. Its chimney has been blocked up. The 1926 plan suggests this area contained two bathrooms.

A notch in the masonry, where Room Eight meets the hall, suggest the line of a previous subdivision?
