Boleskine House, Foyers

Existing Fabric Record Report

by LDN Architects LLP

October 2019

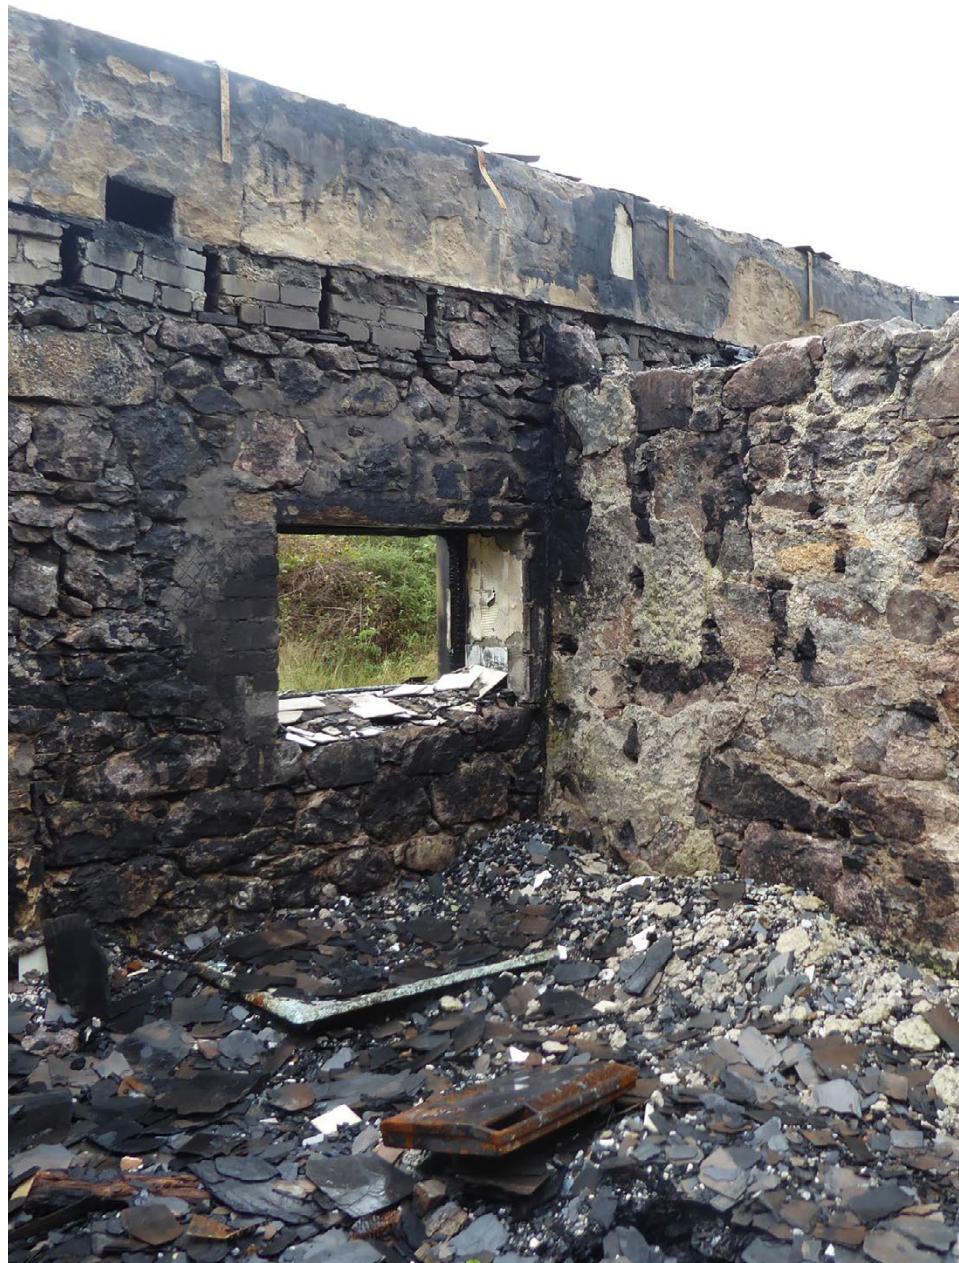
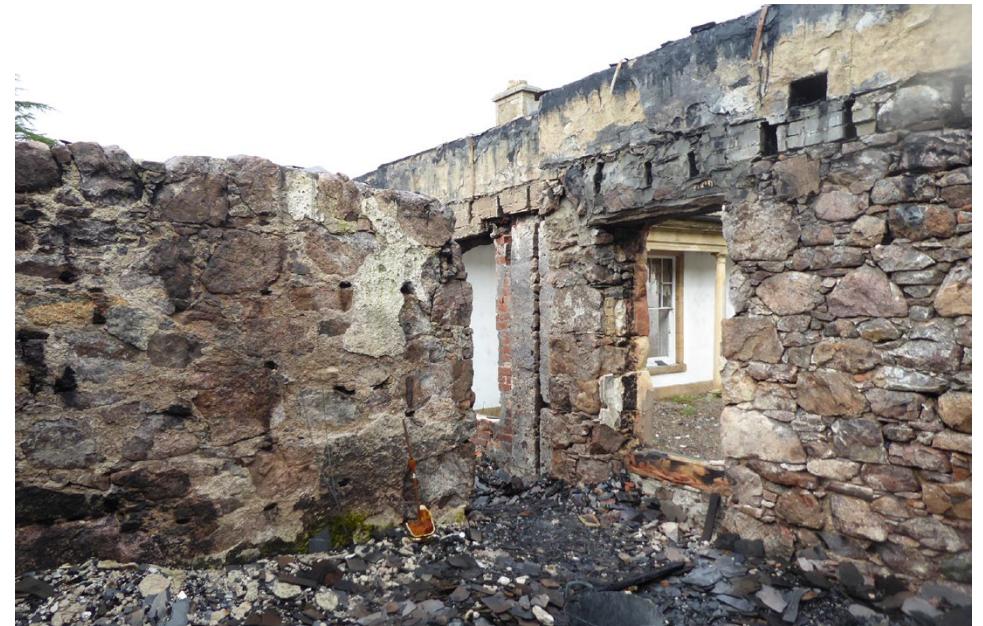
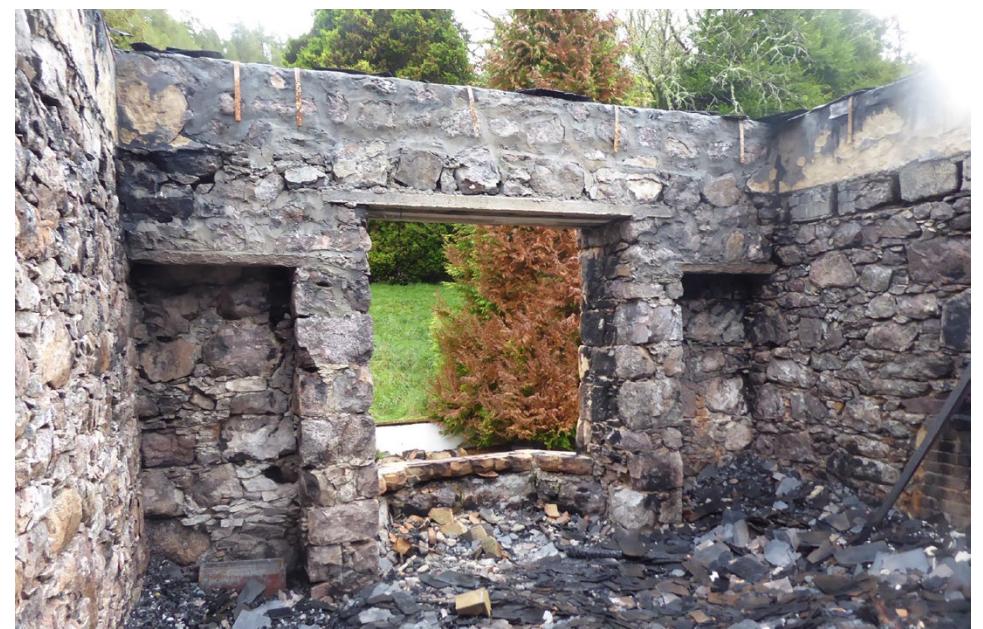
## ROOM NINE

Description: Western return wing.

In common with Room Eight, the wallhead to the external walls has been rebuilt from ceiling level upwards in concrete block and rubble stone over the bay. The bay window lintels replaced in concrete.

It is built in random rubble with yellow sandstone dressings and finished in a cement render.

The elevation drawing from the 1970s show the chimney on the cross wall in place, as well as a wallhead chimney on the West elevation (now closed up). It implies that this wing was re-roofed, suggesting that the rebuilding of the walhead date from this time.

There is a later horizontal window on the West elevation, altered in concrete brick.

The masonry build to the outside walls is consistent and at 580mm thick, is not dis-similar to Rooms Three and Two, particularly in the handling of the dressed openings.

On this basis, we suggest it is of a similar age, although potentially built later based on the harl on the chimney cross wall.

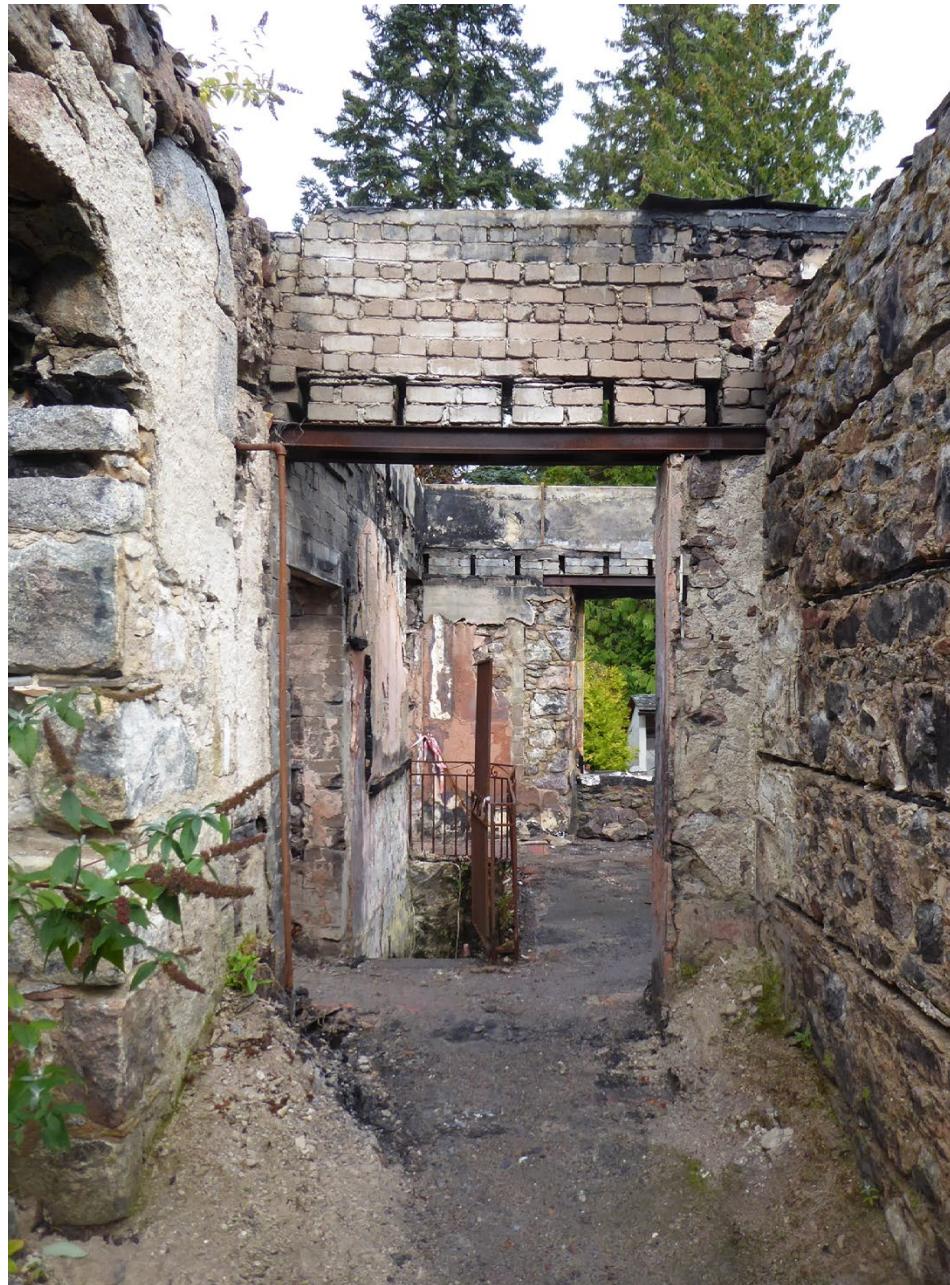
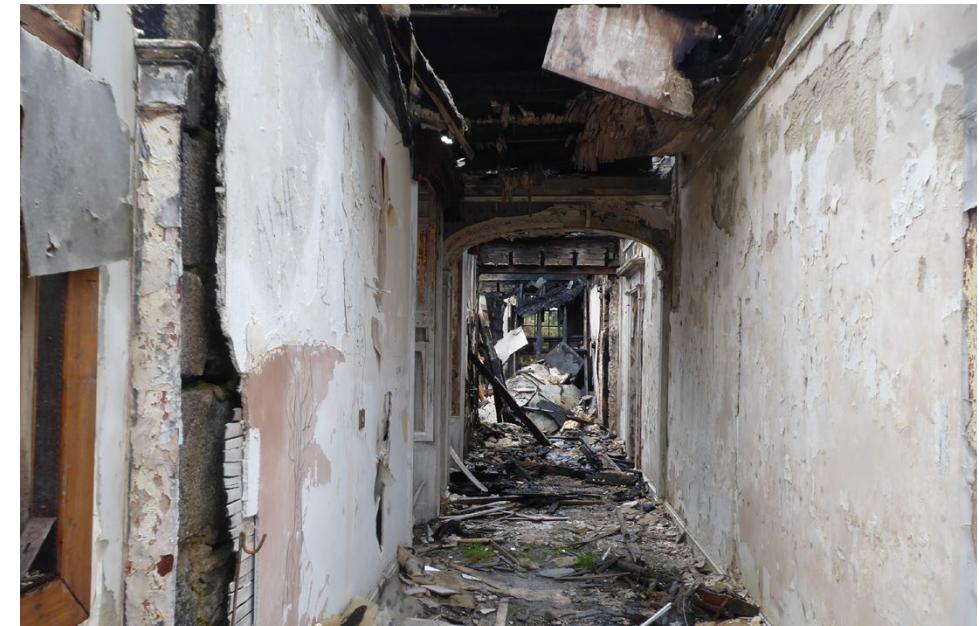
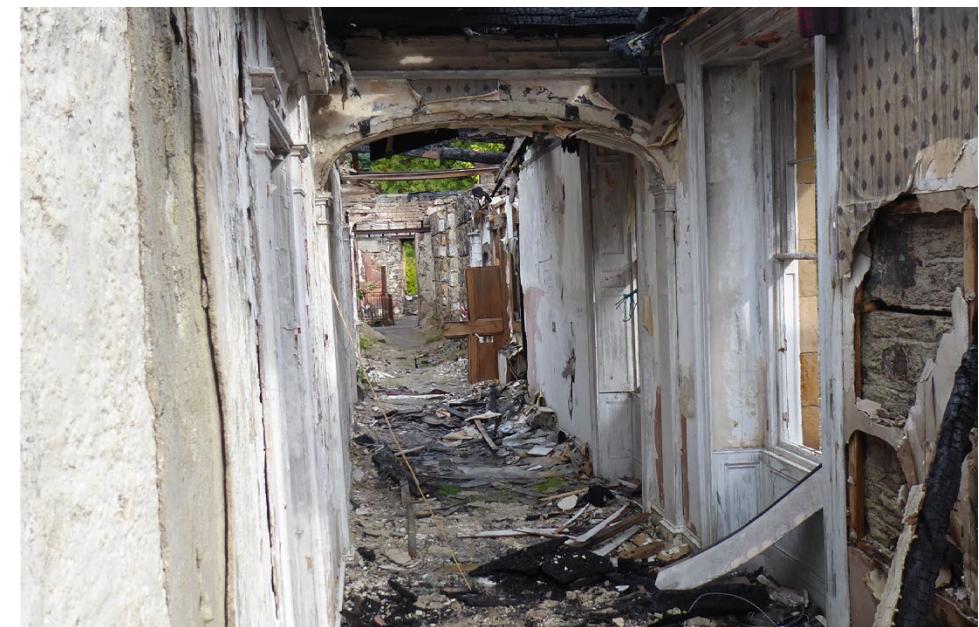
## HALL

Description: South west entrance corridor.

The external courtyard elevation is a symmetrical set piece with a shallow four-bay loggia or colonnade either side of the central pilastered projecting entrance flanked by narrow sidelights. Porch linked to outer bays by shallow loggia supported by slender Roman Doric columns; deep continuous entablature.

The central porch is slightly clumsy at the window sills either side of the door, suggesting alteration.

This external wall is built in coursed field rubble with sandstone dressings. Unlike other walls, it had horizontal timber grounds to take internal lath and plaster finishes, suggesting a different date.

There are risband joints at either end of this wall where this 'screen' junctions the wings, suggesting that it is a later addition and probably dates to nearer 1830 than 1760. This implies that the pilasters were also cut into the earlier wings at either end of the colonnade. If the courtyard side of Rooms Two and Eight were rebuilt when the colonnade was built, they presumably would have horizontal grounds?

There is the potential that the porch enclosure differs in age from the hall screen wall itself.

It is also possible the surviving finishes at the West end disguise variations either side of the porch where granite dressings can just be seen on one side but not the other.

At the entrance there is a steel structure within the ceiling, suggesting alterations.

The opening into Room Four, exposed by the fire, appear cruder and may be an alteration.

As noted above in the text for Rooms Four to Six, there is evidence of old openings and external harl on what is now the North internal wall of this Hall/Corridor. Given the present triple opening to Room Five is on axis with the current entrance, we assume the older symmetrical but closed up openings to Room Five predate this 'screen' wall.

Good surviving evidence of period finishes within hall. The doorcase into Room Six from the corridor appears to be different in style, but in keeping with the period of the remainder of the hall.

Modern detailing to leadwork and colonnade soffit suggesting alterations. This is similar to the slightly projecting eaves detail used throughout where the eaves have been boxed in with a non-traditional detail. In turn, this suggests that the majority of the roof has been reworked at one time
